Debris/Ice/TPS Assessment and Integrated Photographic Analysis of Shuttle Mission STS-79

**DEBRIS/ICE/TPS ASSESSMENT
AND
INTEGRATED PHOTOGRAPHIC ANALYSIS
OF
SHUTTLE MISSION STS-79**

16 September 1996

Shuttle Ice/Debris Systems
NASA/KSC/PK-H7

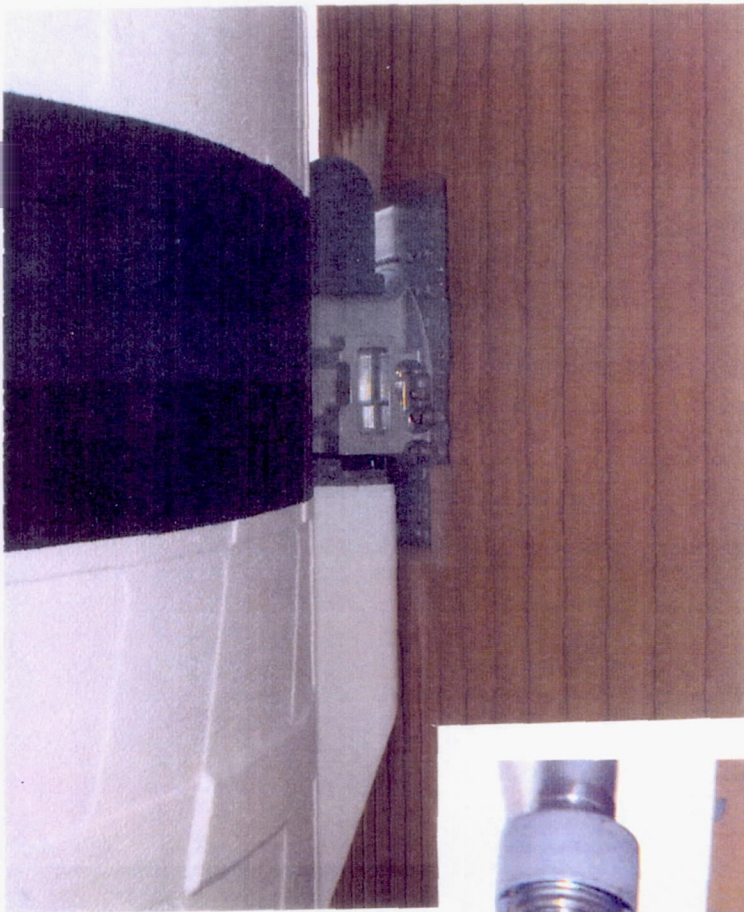
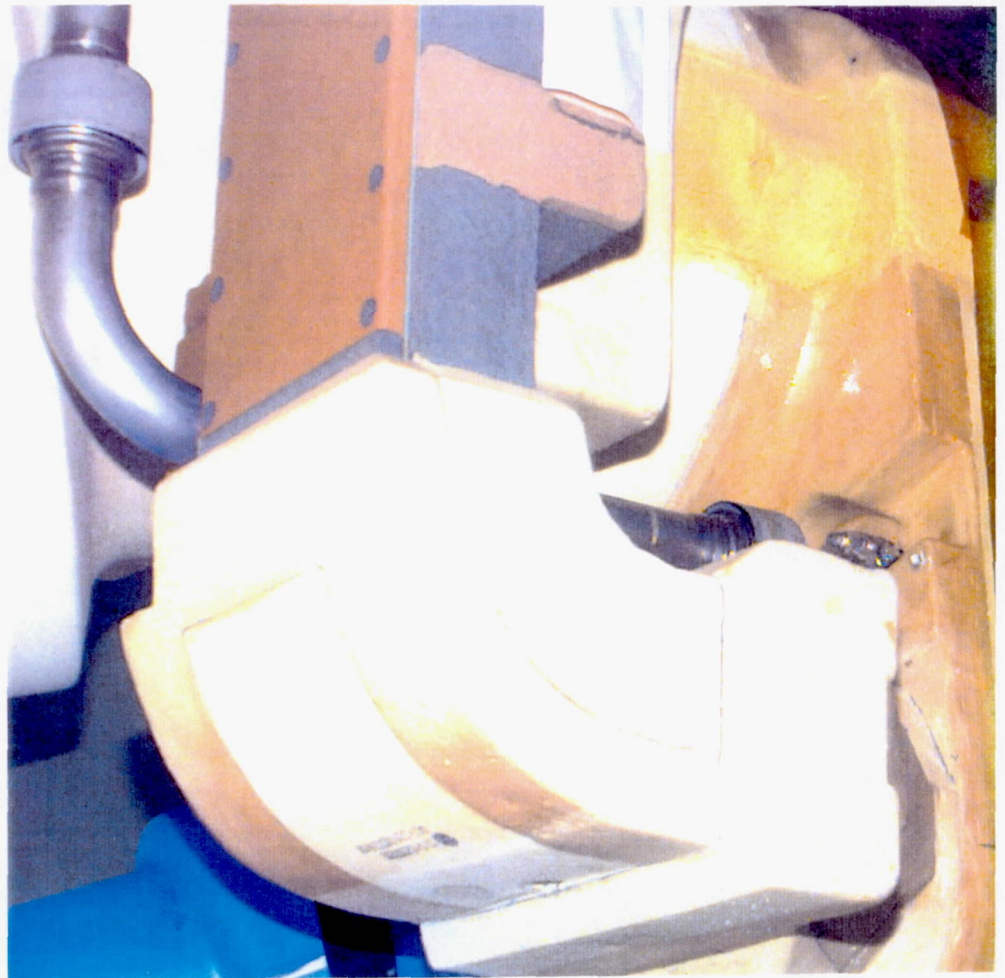
Photo 2: SRB/ET Bolt Catcher and ET LH2 Umbilical Cable Tray

As a weight-savings measure and process improvement, topcoat (Flame Retardant Latex) was not applied to the ET/SRB Bolt Catcher and the ET LH2 Umbilical Cable Tray.

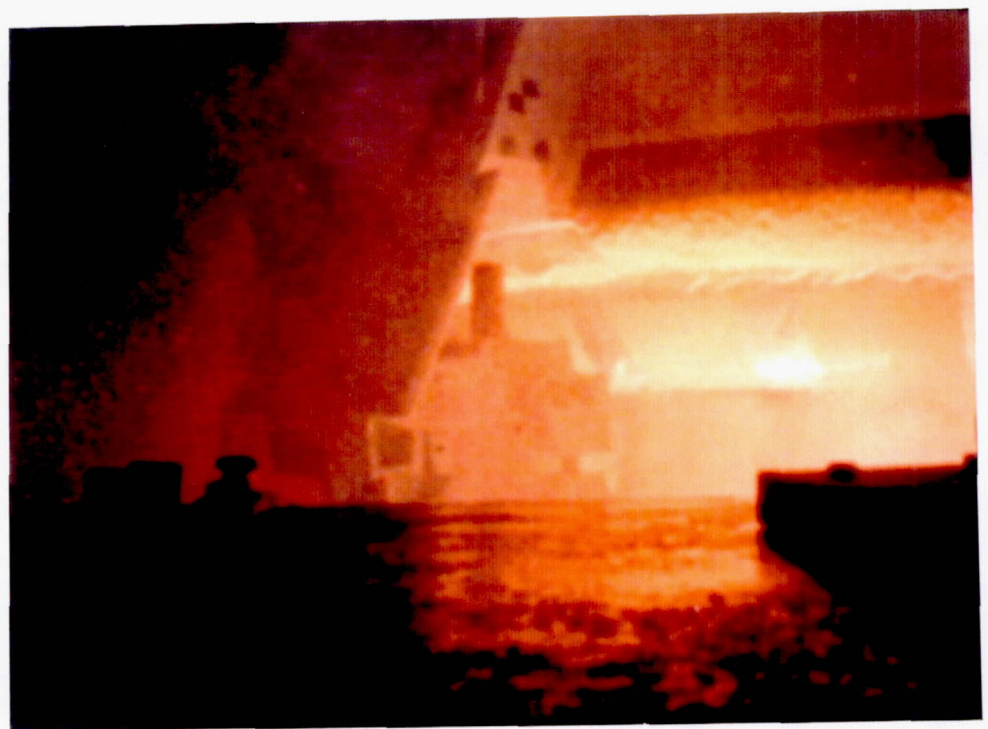
Photo 8: Stud Hang-up

A stud hang-up occurred on holddown post #3. No ordnance fragments or frangible nut pieces fell from the DCS while in the field of view.

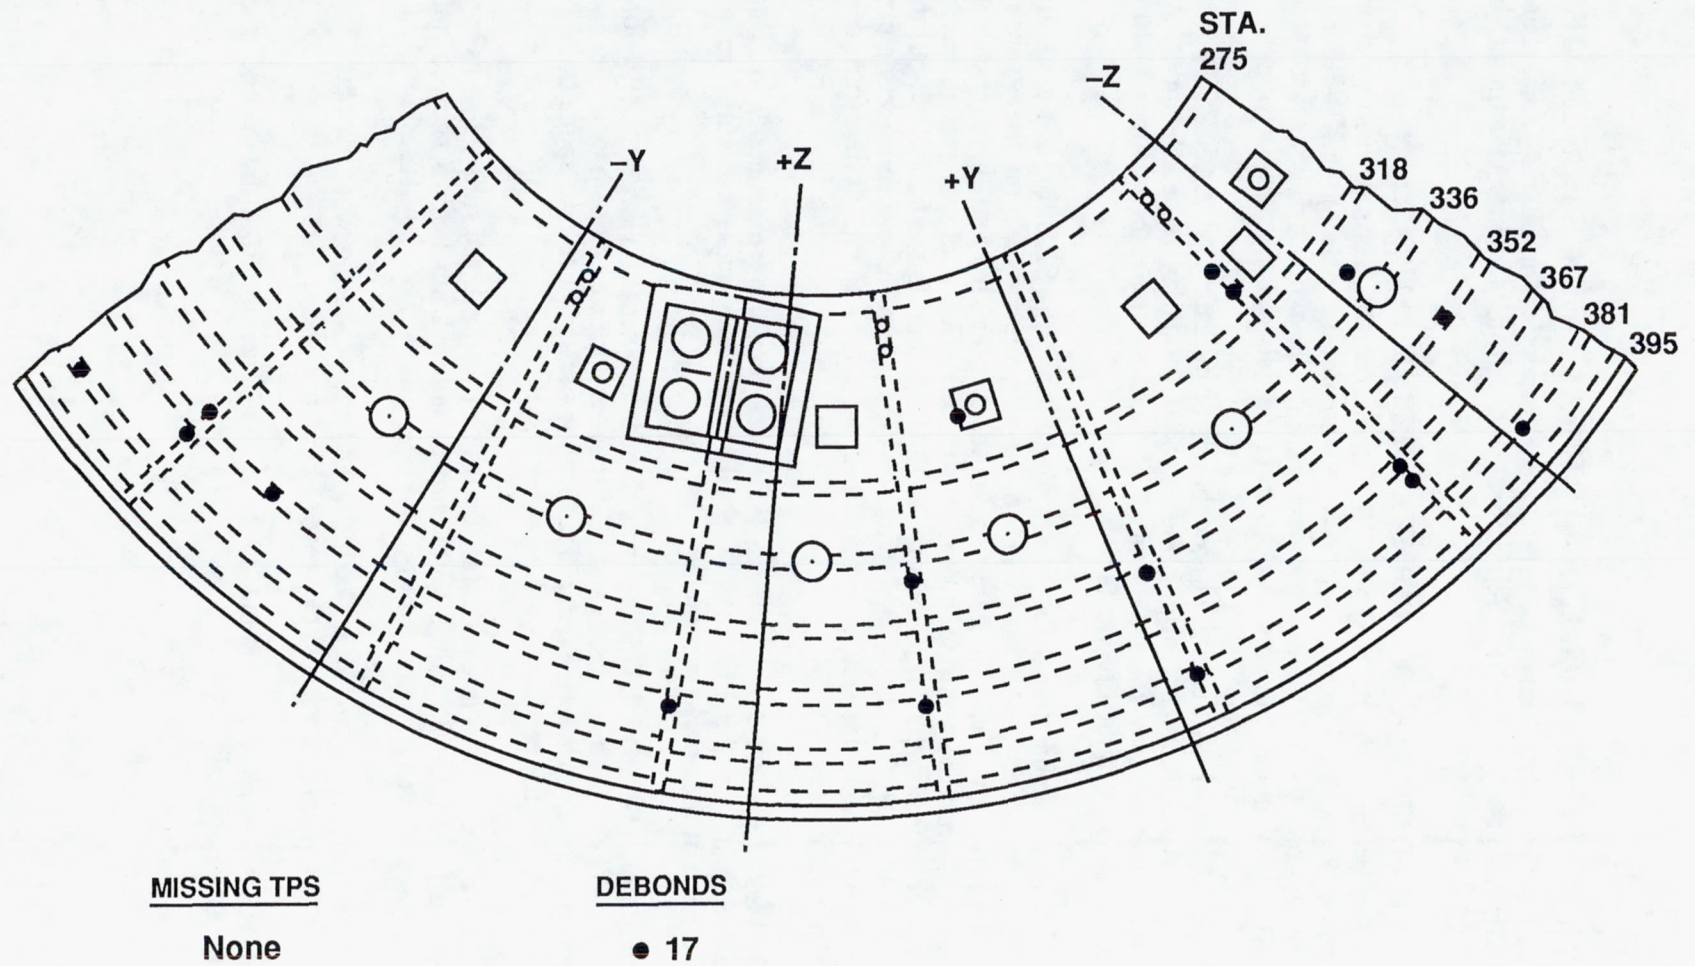
Figure 1: RH SRB Frustum

The RH frustum was missing no TPS. The number of debonds over fasteners (17) was less than average (Figure 1). Hypalon paint was blistered/missing along the XB-395 ring frame where BTA closeouts had been applied. However, most of the exposed BTA substrate was not sooted. The BSM aero heat shield covers had locked in the fully opened position.

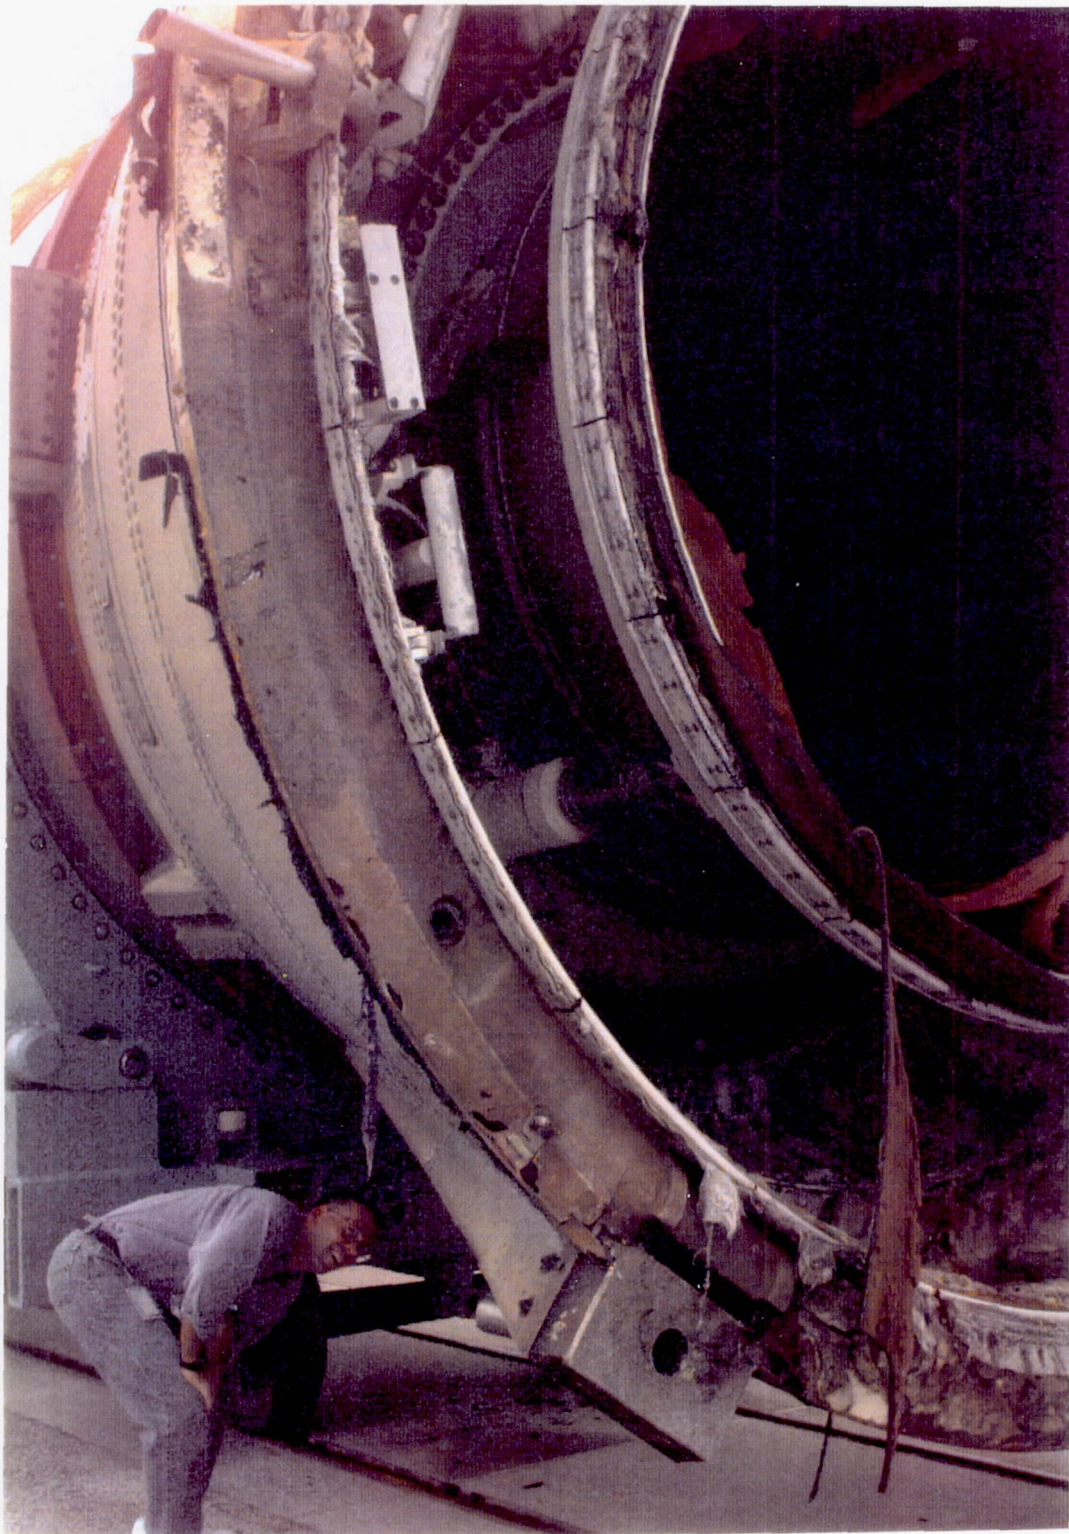
Photo 14: Aft Skirt Aft Ring Missing Foam

Instafoam was missing and the substrate was exposed on the aft skirt aft ring from HDP #2 to the HPU exhaust ducts. Launch films showed numerous light colored particles, believed to be pieces of foam, falling along side the SRB plumes during ascent.

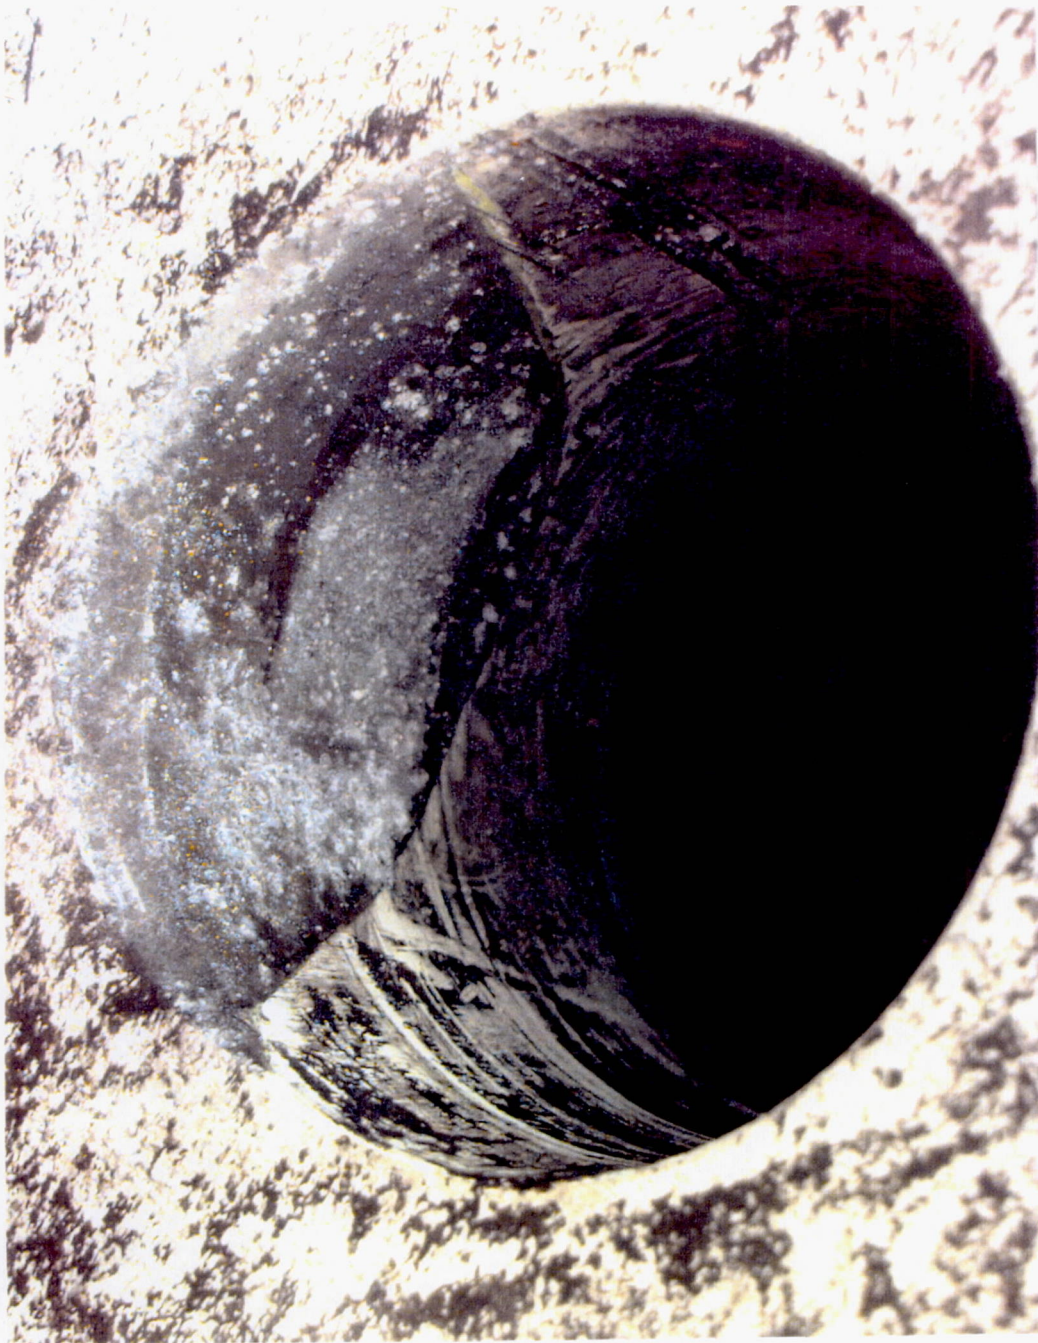
Photo 15: HDP #3 Stud Hole Broaching

A stud hang-up occurred on HDP #3 and the stud hole was broached. The stud hang-up was confirmed in the launch film review.

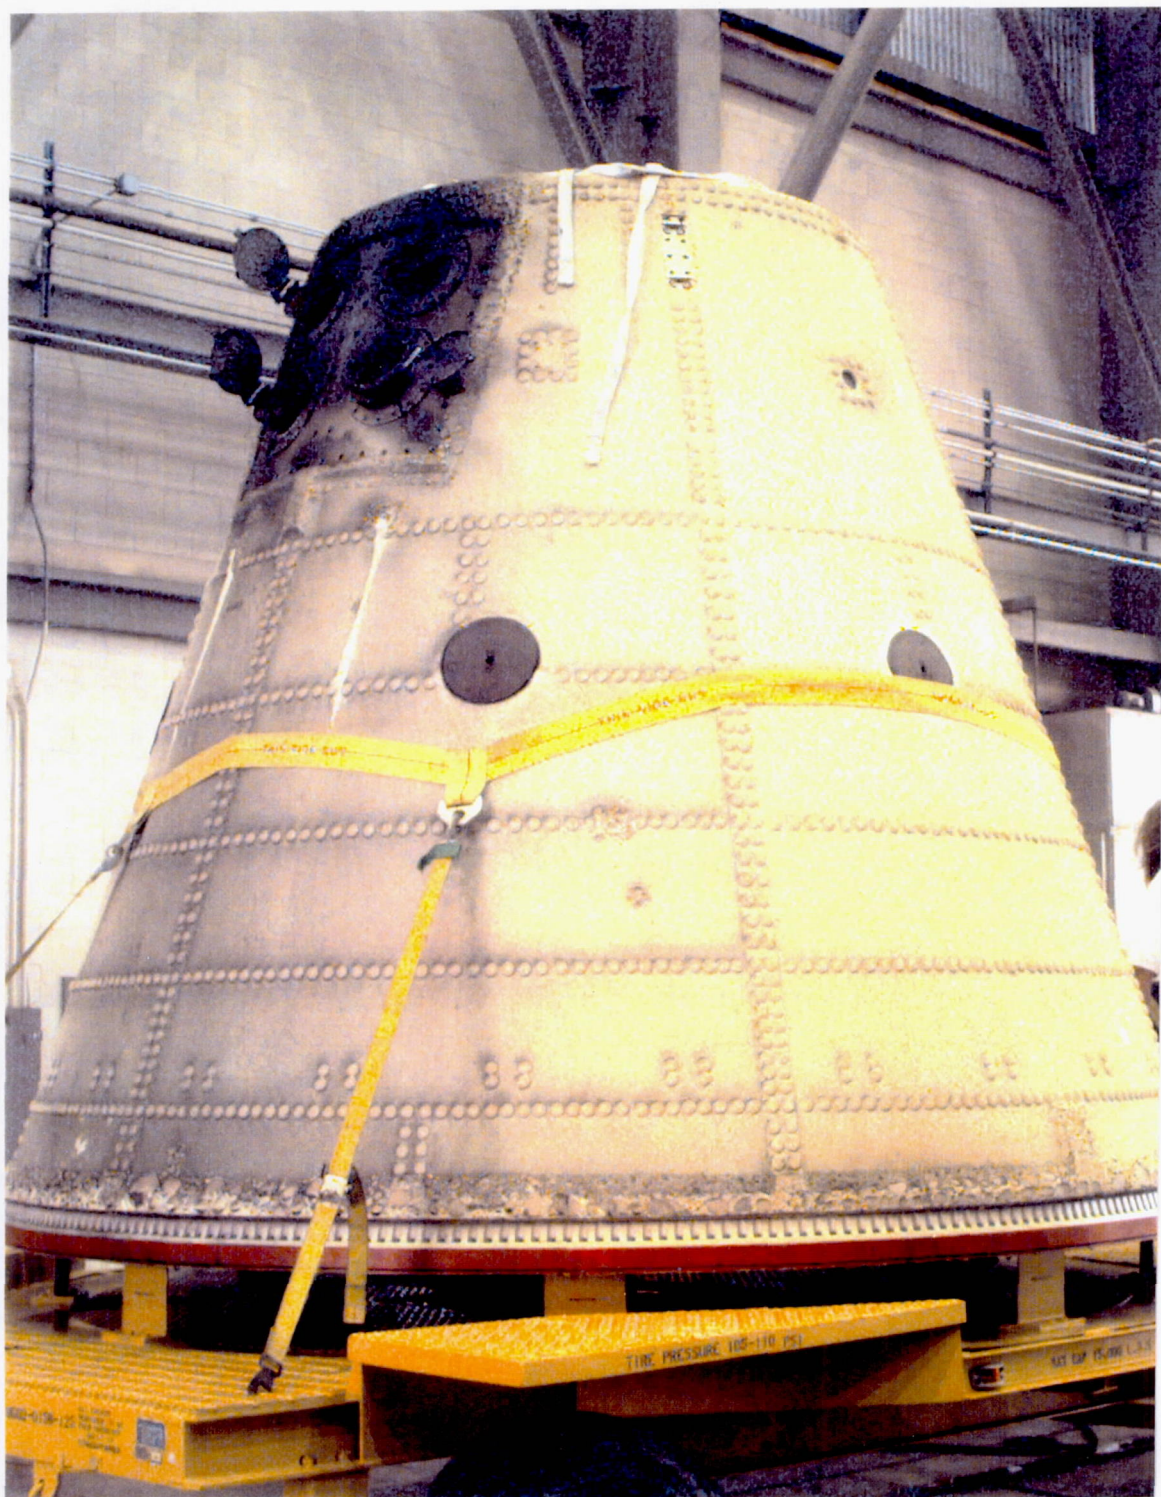
Photo 16: LH Frustum

The LH frustum was missing no TPS. The number of MSA-2 debonds over fasteners (5) was less than average (Figure 2). Hypalon paint was blistered/missing along the XB-395 ring frame where BTA closeouts had been applied. However, most of the exposed BTA substrate was not sooted. The two left BSM aero heat shield covers had been bent by parachute entanglement; the lower right cover was locked in the fully open position, and the forward right cover was missing.

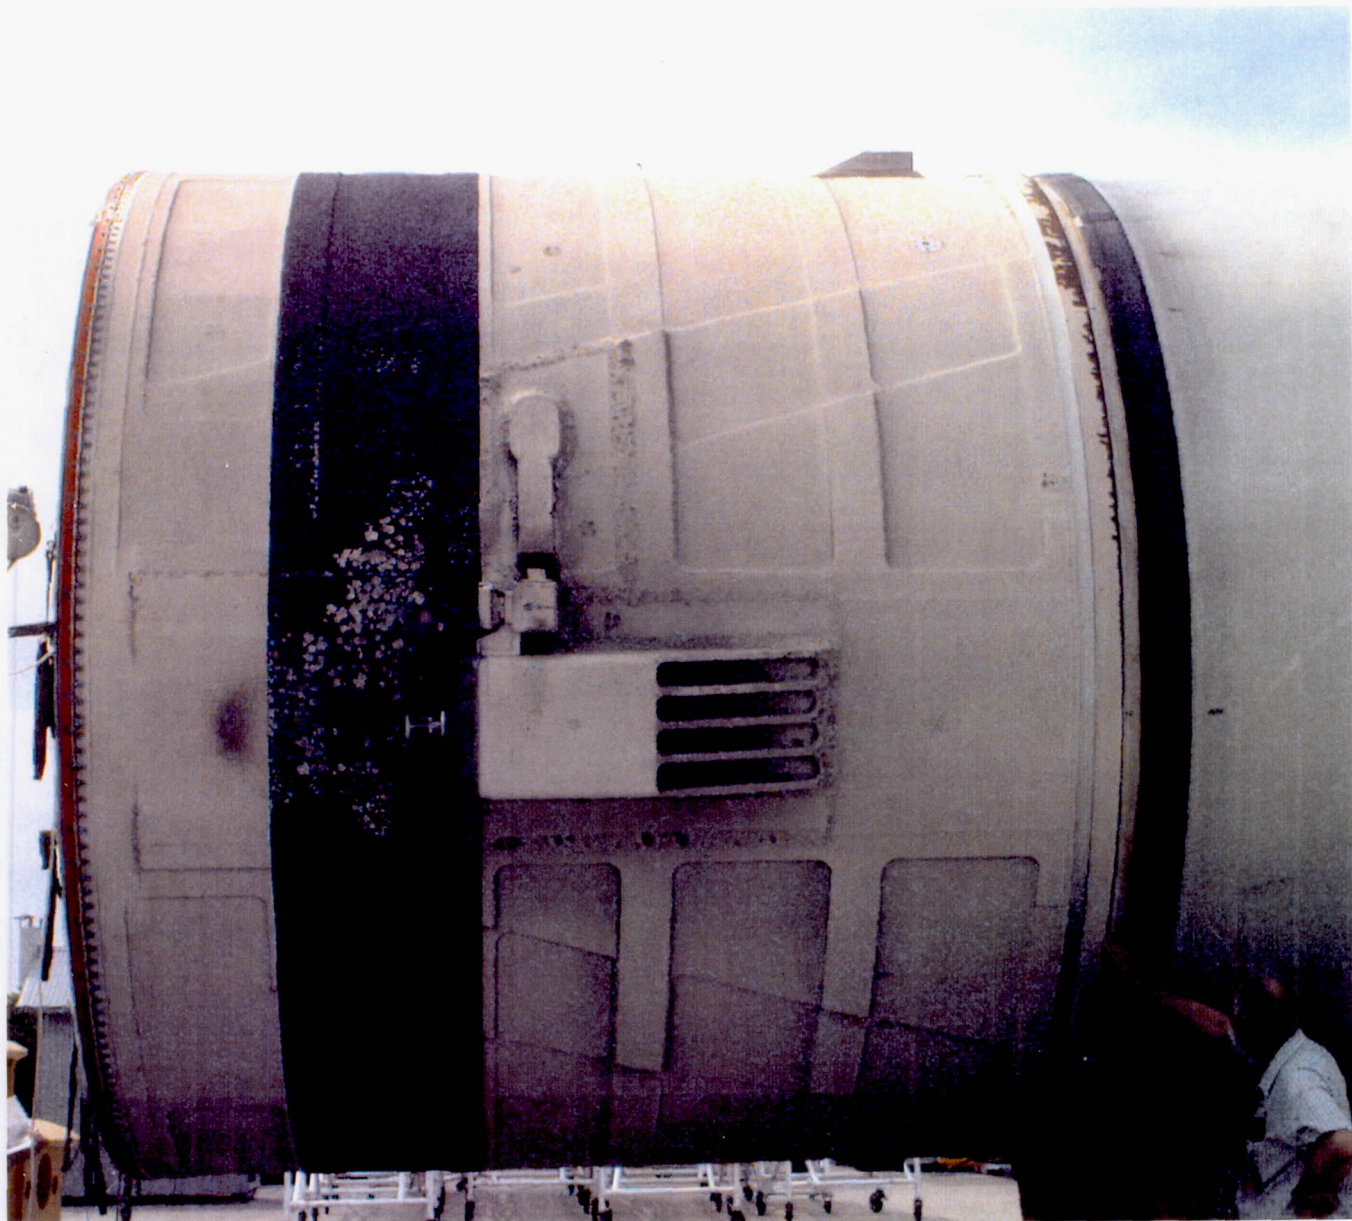
Photo 17: LH Forward Skirt

The LH forward skirt exhibited no TPS debonds. Both RSS antennae covers/phenolic base plates were intact though some of the phenolic layers had delaminated. Hypalon paint was blistered/missing over the areas where BTA closeouts had been applied. No pins or retainer clips from the frustum severance ring were missing or damaged.

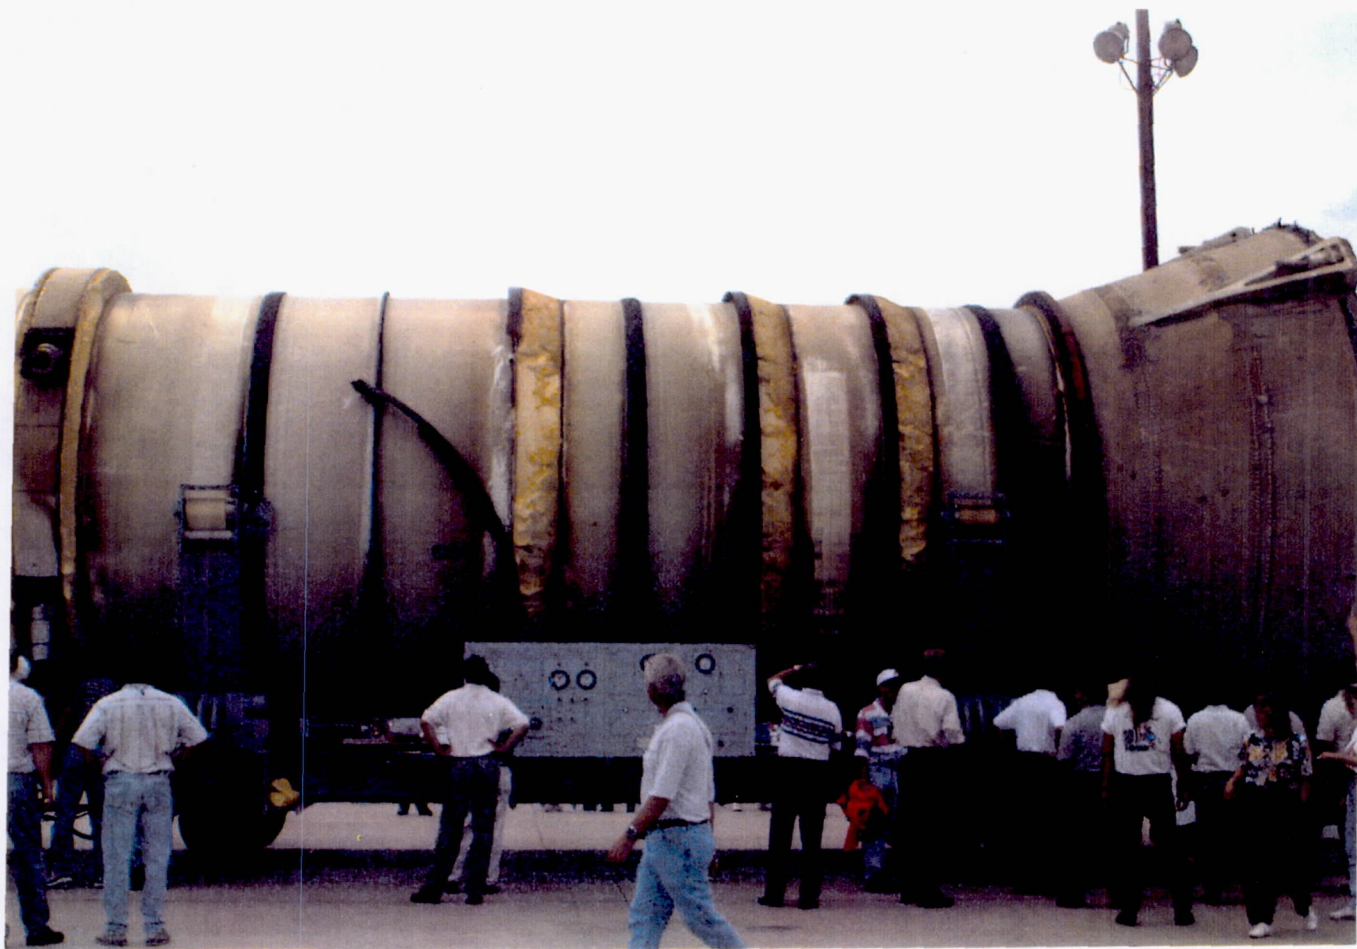
Photo 18: LH Aft Booster/ Aft Skirt

Several stiffener rings had been damaged by water impact. The forward stiffener ring had separated from the aft booster from 190 to 240 degrees.

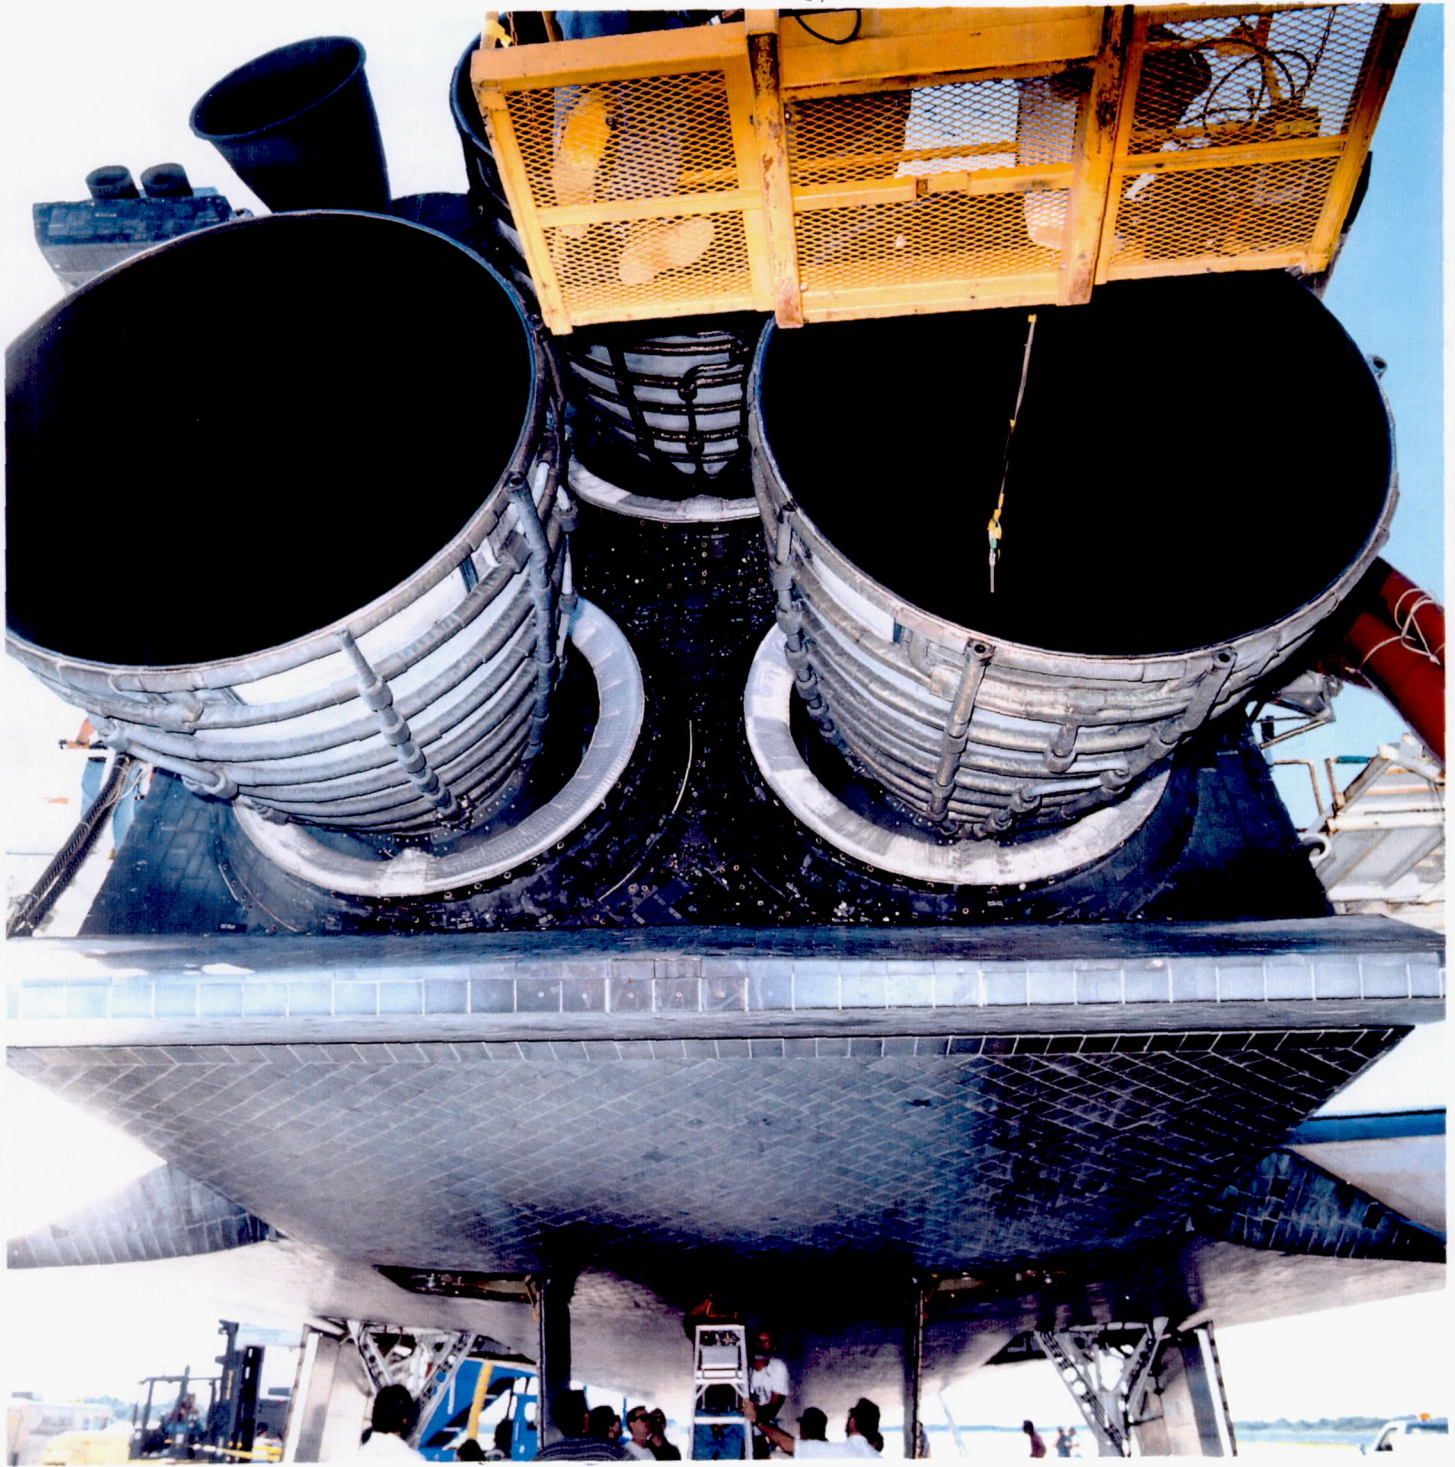
Photo 22: Base Heat Shield/SSME's

All three SSME Dome Mounted Heat Shield (DMHS) Blankets were in excellent condition.

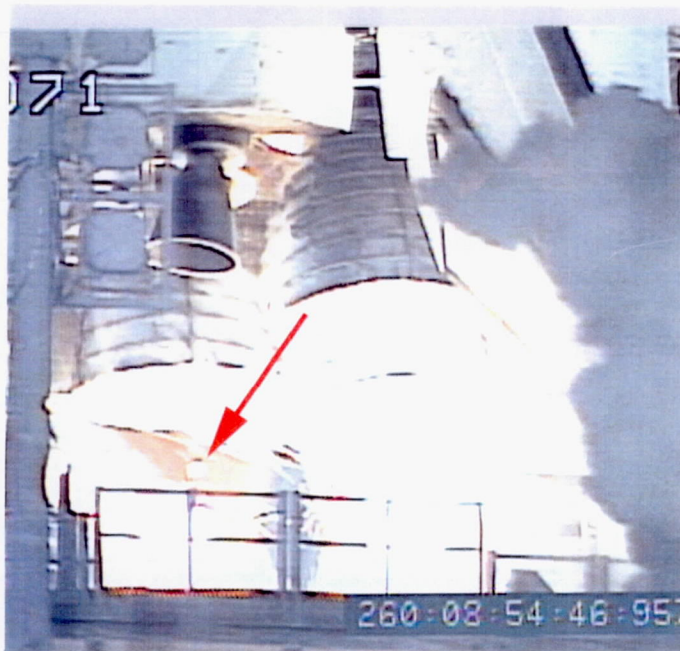
Figure 2.1.1.1 Debris Aft of the SSMEs During SSME Ignition

Several pieces of light-colored debris (probable RCS paper) were seen aft of the SSMEs during SSME ignition (08:54:45.623, 08:54:46.957 UTC).

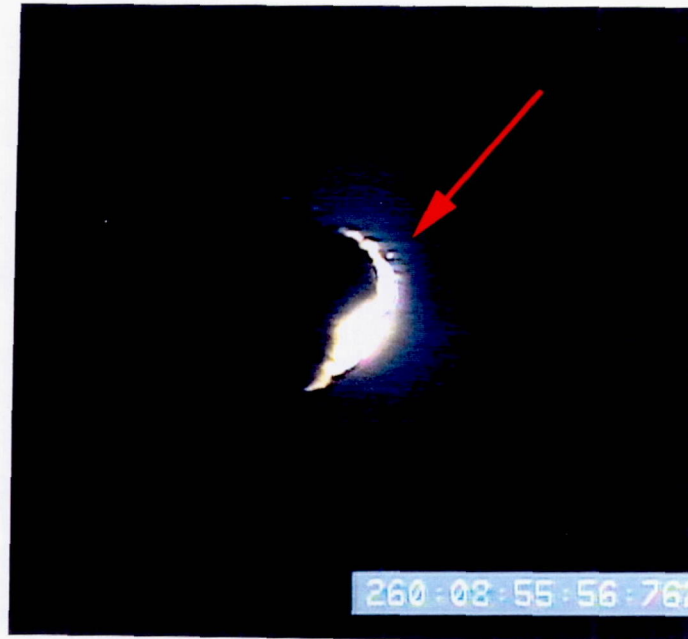
Figure 2.1.3.3 Debris Falls Along SRB Plumes

Multiple pieces of debris (at least nine), possible SRB aft skirt instafoam, were seen falling aft along the SRB exhaust plume during ascent (08:55:54.927 UTC to 08:56:15.281 UTC). A single piece of debris was seen falling aft along the SRB exhaust plume at 08:56:49.7 UTC. Debris aft of the launch vehicle during ascent has been seen on previous missions.

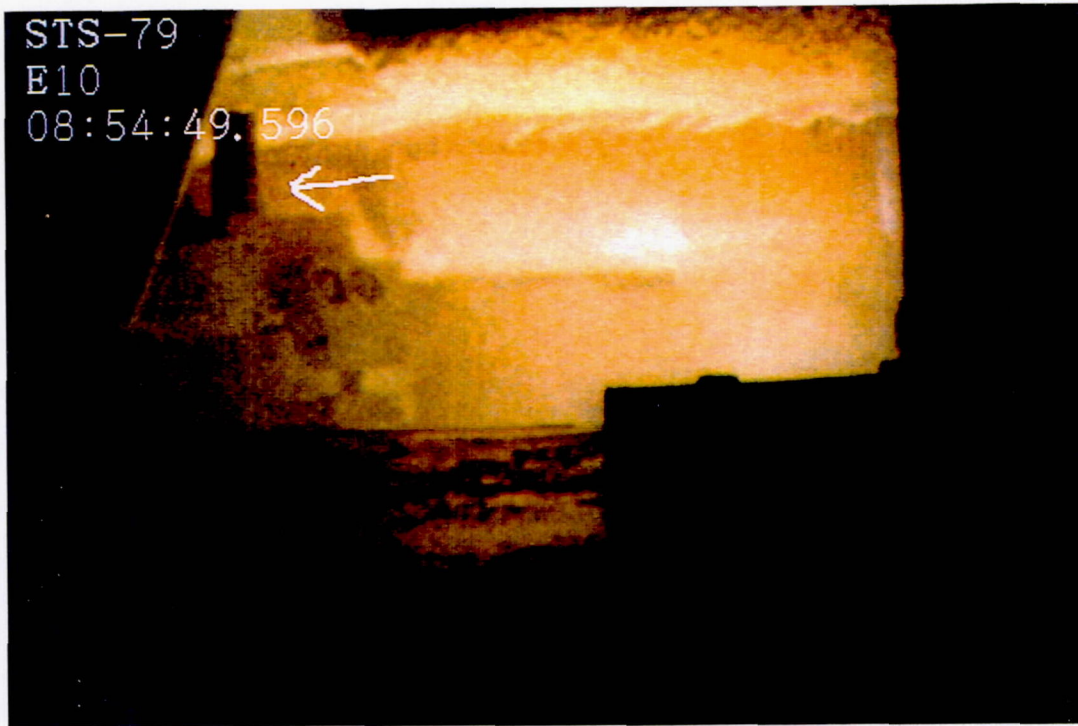
Figure 2.2.7 Bolt Hang-Up at Holddown Post M-3

A bolt hang-up was seen at the RSRB holddown post M-3 at liftoff (08:54:49.594 UTC). No debris fragments were seen near the DCS during the hang-up and bolt release. SRB holddown bolt hang-ups have been seen on five of the last seven previous missions. See Table 2.2.7. No follow-up action was requested.

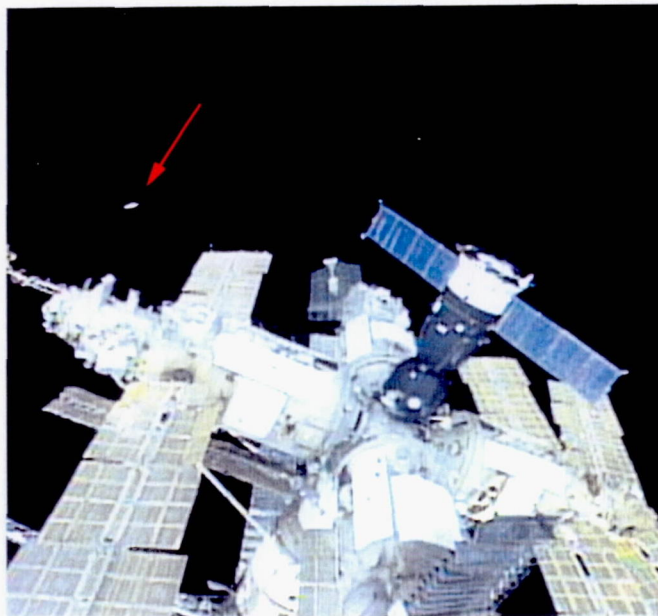
Figure 2.5.2 Debris Seen from Payload Bay Camera after Mir Docking

A reflective-appearing piece of debris was seen from Orbiter payload bay camera B after docking to the Mir space station. The debris did not appear to contact the Orbiter or the Mir Space Station. No follow-up action was requested.
